**Architectural and historical impact assessment for the house and  
associated outbuildings known as Kingthorpe, Umlaas Road district,  
KwaZulu-Natal**

**Prepared for: Mr Neville Hattingh  
Blue Environmental Consultants**

July 2007

**architecture: research: conservation: anthropology: impacts consulting**

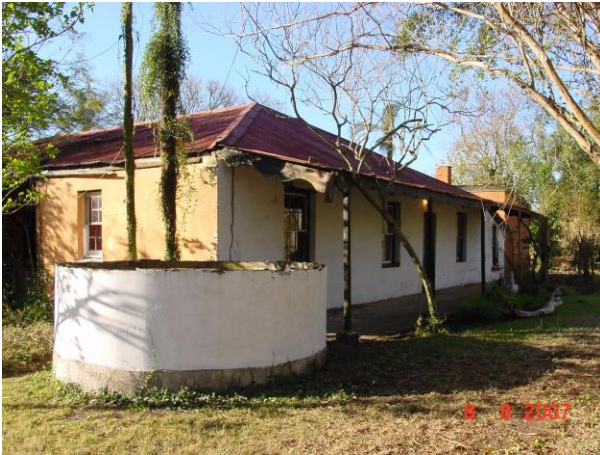
Fig 2: view of house from south

The Kingthorpe house is red brick, plastered in places (see above) under a shallowly-pitched corrugated sheeting roof. It has a veranda to the north and the east. It is a typical farmhouse that sits in association with a number of other buildings of a more practical nature. There is an uncomfortable addition, also over the age of 60 years, which occupies the north east corner, constructed out of red brick but with a parapet and a mono-pitched roof. The garden is typically and exotically planted, with established palm trees and jacarandas.

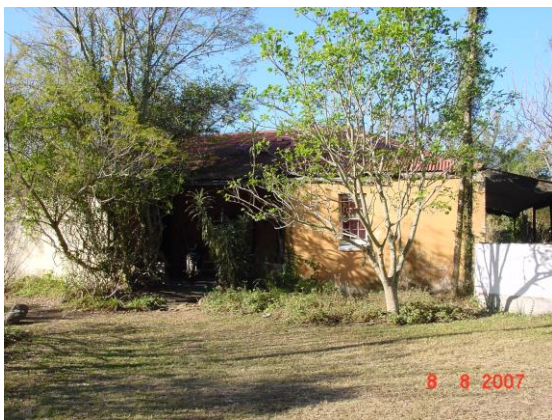
Fig 6: Back veranda- first visit

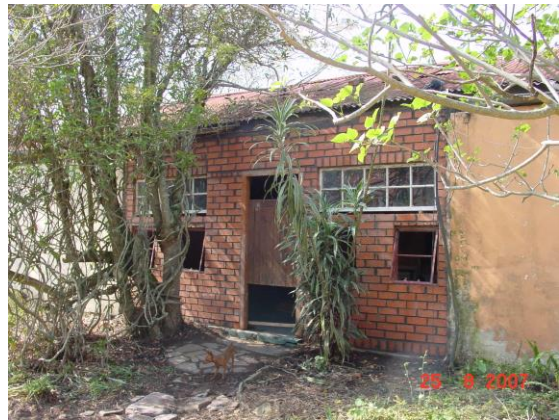
The condition of the external part of the house is generally good, with a little more than basic maintenance being needed. Internally, the house is unusual in that all the internal walls are of partition boards, with chair rails and the decorative *accoutrements* of the period. The main living room has a magnificent brick fireplace at the western end. (this was the kitchen in 1918 when the Fuller family moved in). Rather disturbingly, on a second visit on Saturday 25 August, it was found that the rear veranda was in the process of being bricked up in the most alarming manner possible (see Fig 7)

Fig 7: Back veranda- second visit

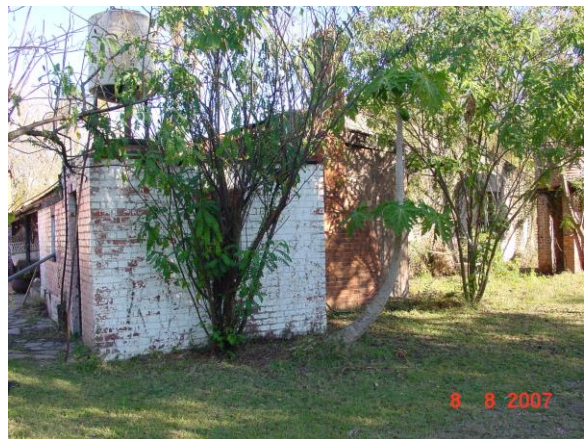
Fig 9: addition on the north-eastern corner

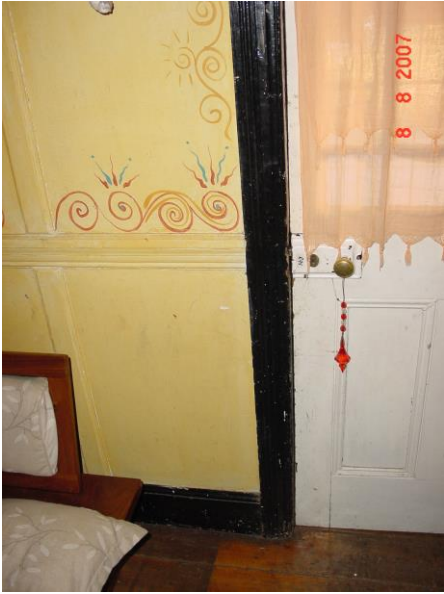
Fig 10: door from main room to east veranda- note the chair rails in the paneling

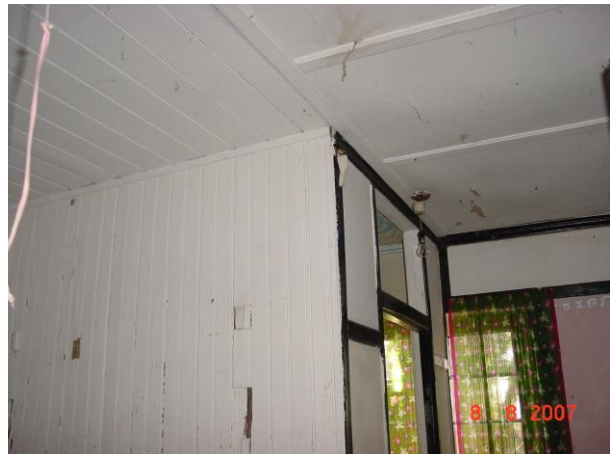
Fig 13: Black painted cover strips as described by Mr Fuller

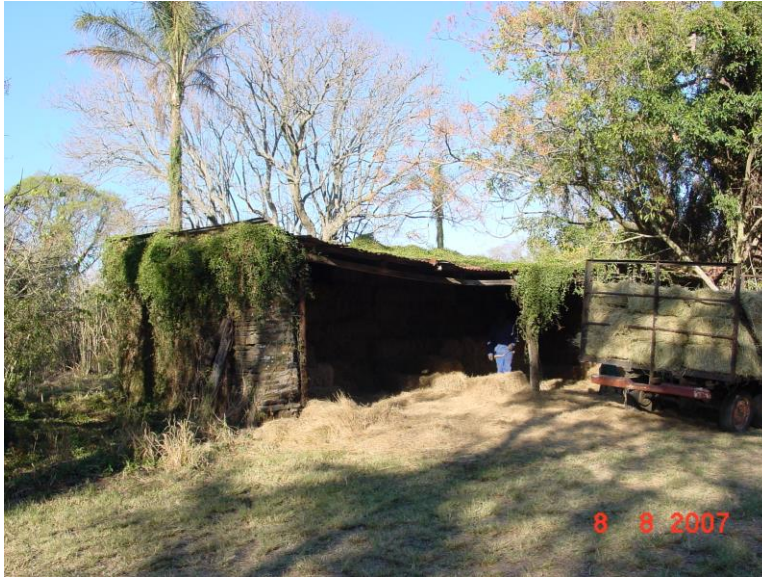
Fig 19: Showing shale barn from the north

This is a ramshackle though nostalgic agricultural building, with three sides of shale wall holding up a corrugated sheeting roof covered in cats-claw creeper. This, according to Mr Fuller, was used as an open barn. It is situated next to the house.

Although this building has nostalgia value, it is not of any significance architecturally, technically, scientifically, socially nor historically. It is protected under the Heritage Act no 10 of 1997, being older than 60 years.

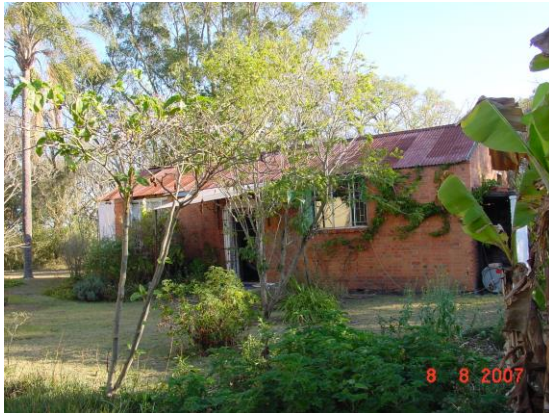
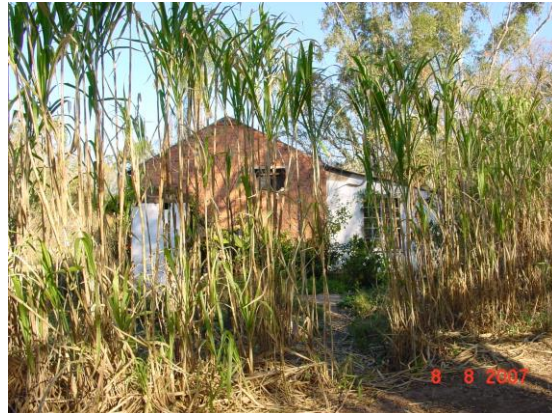
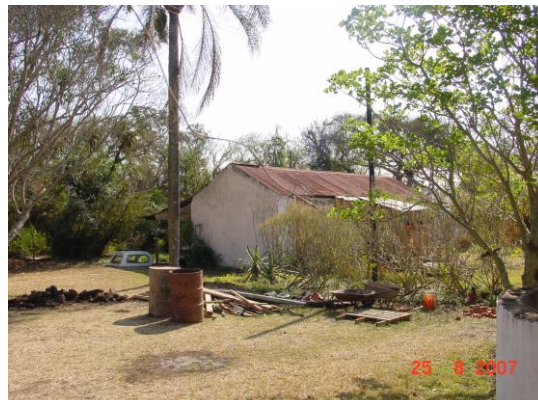
Fig 20: showing barn

Fig 21: Barn from the north

Fig 23: barn from the south east

This is a saddle backed shed with a mono-pitch rear addition, which has been painted. The walls are of wire cut bricks and have eroded mortar joints, suggesting mud mortar at the time of construction. This is corroborated by Mr Fuller who says that the cement (probably lime) was pointed on the extreme outside, whilst the inner pointing was of mud. The tenant in this building called this the 'cowshed', but this was disputed by Mr Fuller who says that it was just a barn, and that his father had subdivided the internal spaces to make it habitable.

Although the structure is protected by the provincial Heritage Act, no 10 of 1997, and is a tidy example of a rural structure, it has been much altered and has no value socially, historically, architecturally, technically nor architecturally. However, the wire cut bricks are salvageable in the event of demolition.

**Recommendations:** demolition of the outbuildings, should it be necessary, is not seen as problematic in relation to the KwaZulu-Natal Provincial Heritage Act no 10 of 1997. Indeed, the building constructed of rammed fly-ash and the big shed are not protected by this Act of Law.

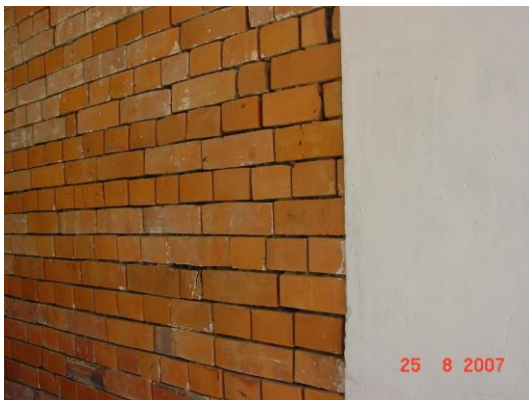
Fig 22: Showing joints

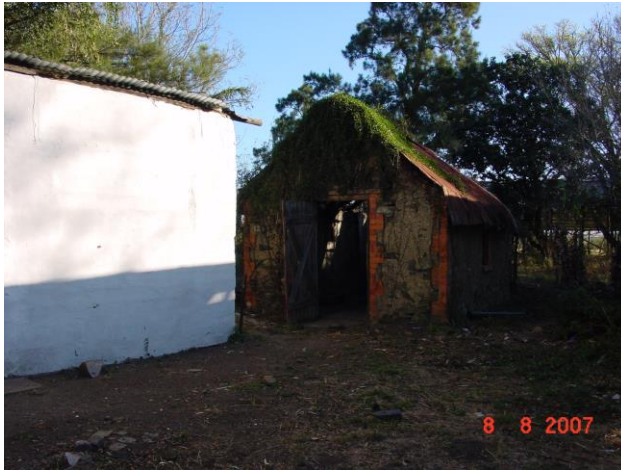
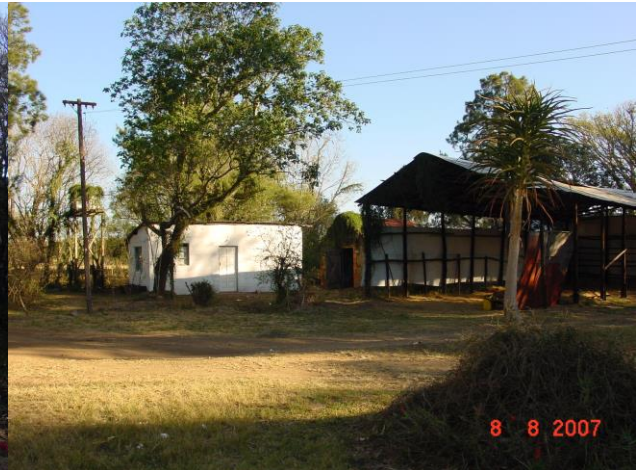
Fig 24: entrance to cool-room building

Fig 25: group showing fly-ash rammed building on left and cool room behind shed structure.

This building was noted by Mr Fuller as having been a cool-room and an incubator.

It is protected under the Heritage Act no 10 of 1997, being older than 60 years. In some ways I consider this the most interesting building on the site, for its mixed construction.

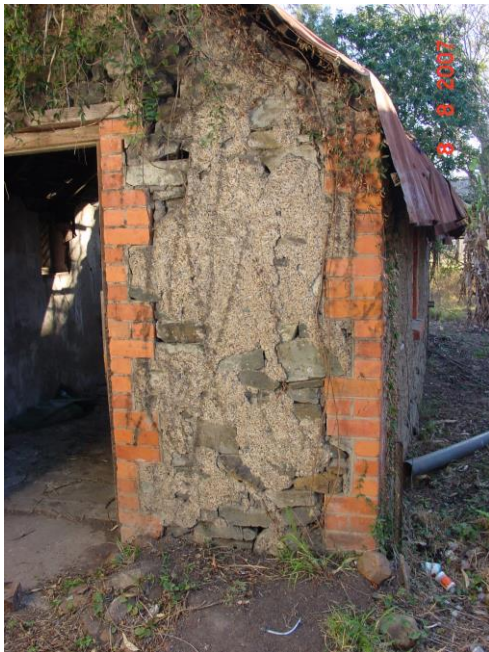
Fig 26: showing construction of cool-room

The building described is a small structure tucked behind other farm buildings. It consists of mixed material construction and is in a dilapidated state. The edges are brick constructed and the rest is a mixture of shale, cement and plaster. The flagstoned floor inside is collapsing at the rear and the roof has largely disappeared. There is a window which has evidence of wooden louvers which have long ago fallen out.

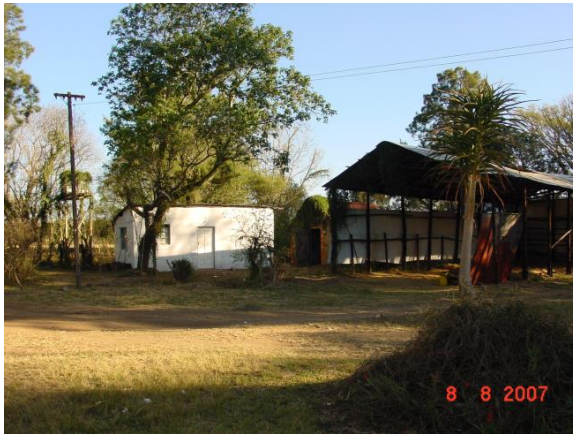
Fig 27: showing building as part of group

This building does not fall within the 60 year clause for the KwaZulu-Natal Heritage Act, and has no social, architectural, technical, historical nor scientific significance. Demolition, should it be requested, would be acceptable.

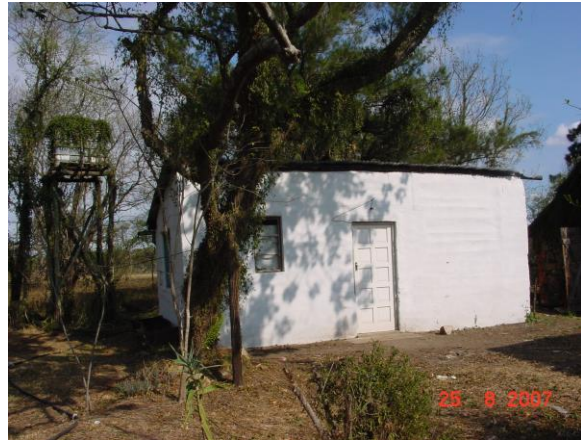
Fig 28: Showing building close up

This building was constructed by Mr Fuller for one of the tenants. It is made of rammed fly-ash and concrete and was, according to Mr Fuller, the cheapest building that he had ever built.

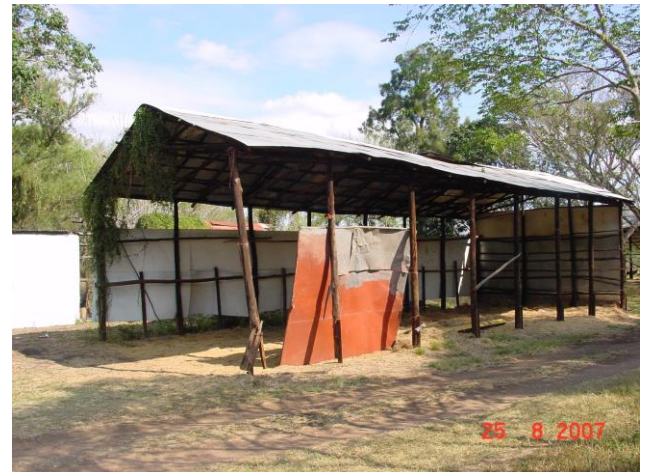
Fig 30: Showing shed

The shed is a large open agricultural space which is constructed of gum-poles and sheeting. It is bordering on rickety.

This building does not fall within the 60 year clause for the KwaZulu-Natal Heritage Act, and has no social, architectural, technical, historical nor scientific significance. Demolition, should it be requested, would be acceptable.
